## AN EXAMINATION OF THE RELATIVE IMPACT OF COMMON POTABLE WATER DISINFECTANTS (CHLORINE, CHLORAMINES AND CHLORINE DIOXIDE) ON PLASTIC PIPING SYSTEM COMPONENTS

**Sarah Chung, Ken Oliphant, Patrick Vibien and Jingguo Zhang  
Jana Laboratories Inc., Aurora, Ontario, Canada**

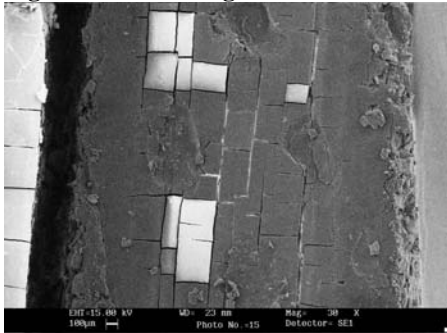
**Figure I: SEM Image of the Chlorine Dioxide Exposed Specimen, Inner Surface**

Figure I shows the inner surface degradation and cracking observed by SEM for the chlorine dioxide tested specimen. In Figure II, a cross-section of the failure crack is shown. Cracking and degradation, consistent with brittle oxidation, is observed through the pipe wall. The degradation level is observed to be highest at the inner exposed pipe surface and decreases through the pipe wall. Rupture of the final section of the wall appears to have occurred through a ductile or fast fracture type of mechanism and does not show the characteristics of degradation observed in the inner and mid pipe wall. Oxygen (as observed by EDX (Table II)) is present through the specimen wall, indicating oxidation of the specimen through the fracture surface. EDX analysis also reveals trace levels of chlorine near the inner surface. The presence of the carbonyl peak, as shown in the FTIR spectrum in Figure III in the region of  $1812$  to  $1660\text{ cm}^{-1}$ , provides further evidence of oxidation of the inner pipe surface. A significant overall depletion in the stabilizer, as indicated by the significant decrease in the OIT values in Table II, is also observed through the entire specimen. Overall, oxidative degradation are highest at the inner exposed surface decreasing through the pipe wall.

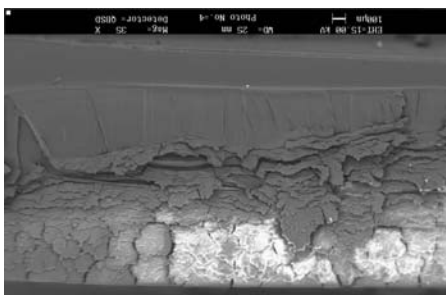
**Figure II: SEM image of the fracture face at the crack**

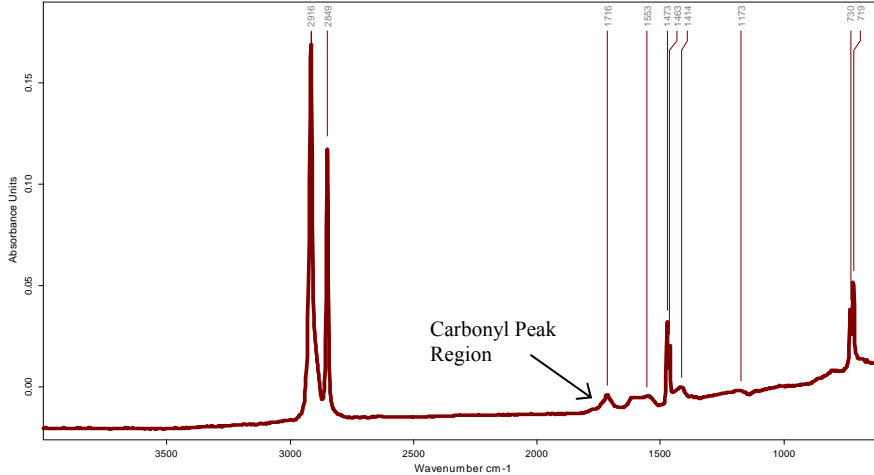
**Figure III: FTIR spectrum of the inner surface near the crack for a Chlorine Dioxide exposed sample**

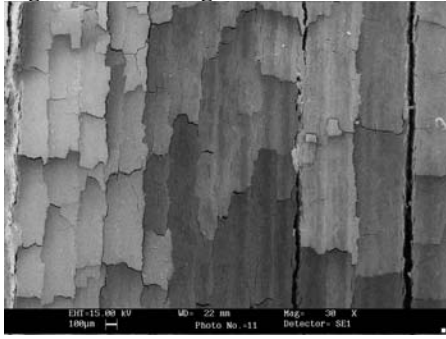
**Fig IV: SEM image from inner surface of Chloramines sample**

Extensive degradation and flaking of the inner surface of the chloramines exposed specimen is observed in the SEM of Figure IV. Similar to the chlorine dioxide exposed specimen, the cross-section of the failure crack, as shown in Figure V, is observed to have cracking and degradation consistent with brittle oxidation. The observed degradation is heaviest at the inner pipe surface and decreases through the specimen. Rupture of the final section of the wall appears to have occurred through a ductile or fast fracture type of mechanism and does not show the characteristics of degradation observed in the inner and mid pipe wall. EDX reveals oxygen through the specimen wall with only a trace level of chlorine in the mid wall. Oxidation, as observed by the presence of carbonyl peaks in Figure VI, is observed to be present from the inner to the mid pipe wall. No significant degradation is observed near the outer wall (confirming rupture of the final ligament thickness through non-oxidative mechanisms). Significant depletion of the stabilizer, as observed by the low OIT values in Table III, is observed through the entire pipe wall.

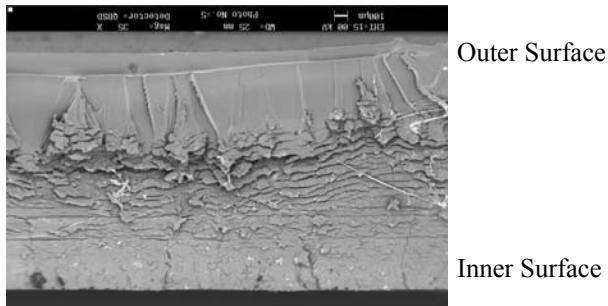
**Fig V: SEM image of the fracture face at the crack of Chloramines sample**

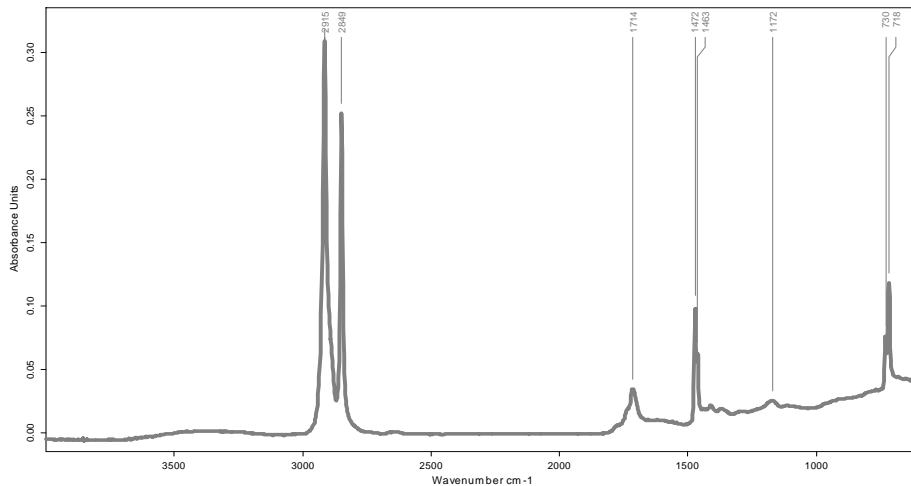
**Fig VI: FTIR spectrum of the inner surface near the crack of the chloramines sample**

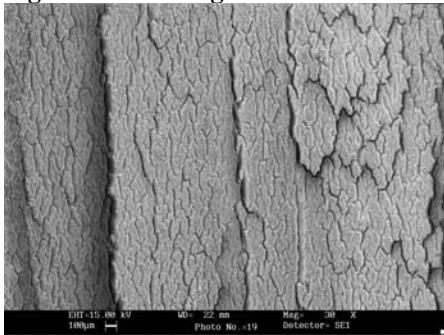
**Fig VII: SEM image from inner surface of Chlorine sample**

As shown in Figure VII, extensive micro-cracking of the inner surface is observed for the chlorine exposed specimen. The fracture surface (Figure VIII) shows cracking and degradation consistent with oxidative degradation. EDX analysis reveals that Oxygen is present through the entire specimen wall. Chlorine is observed in the inner and mid walls (Table IV), consistent with chlorine substitution on the PEX backbone. The levels observed are noticeably higher than the trace levels observed for the chlorine dioxide and chloramines tested specimens. Oxidation is observed through the entire specimen wall thickness, with a lower level of oxidation near the outer surface, as indicated by the presence of the carbonyl peaks shown in Figure IX. The OIT values in Table IV indicate significant stabilizer depletion through the entire specimen wall thickness.

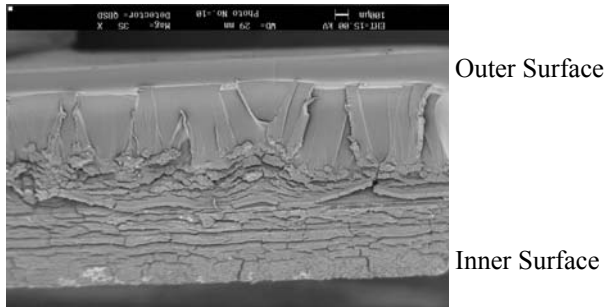
**Fig VIII: SEM image from inner surface of Chlorine sample**

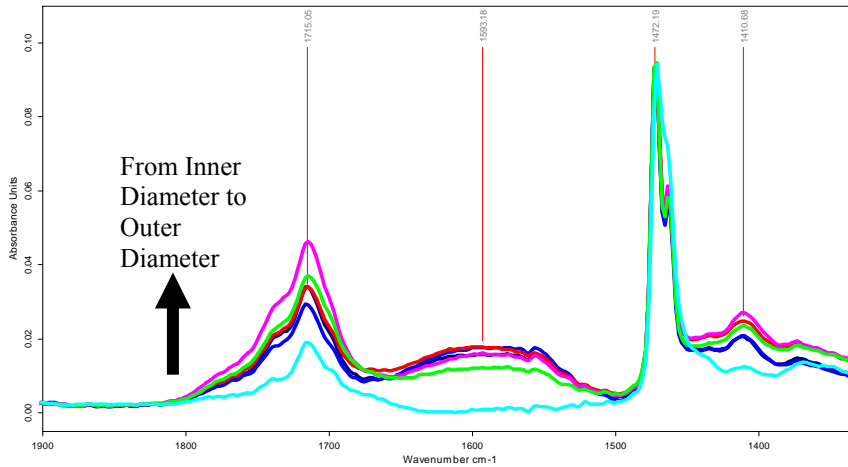
**Fig IX: FTIR spectrum of the Chlorine sample**
