CHLORINE RESISTANCE TESTING OF CROSS-LINKED POLYETHYLENE PIPING MATERIALS

*P. Vibien, J. Couch and K. Oliphant, Jana Laboratories Inc., Aurora, ON
W. Zhou, B. Zhang and A. Chudnovsky, University of Illinois at Chicago, Chicago, IL,
USA, 60607*

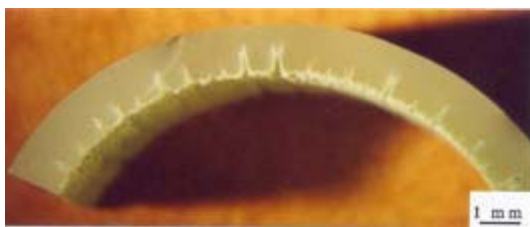
Figure 3: Radial Crack Growth in a PEX Pipe Material.

Figure 3 shows another view of the propagation of the micro-cracks through the pipe wall. Several large cracks are observed, distributed randomly around the circumference of the pipe. In Figure 4, the axial cross section of the same pipe material is shown. The sample was cut along one of the large longitudinal cracks. The advancing crack front is clearly seen in this view. Regions where multiple small cracks have coalesced to form a larger crack are also visible.

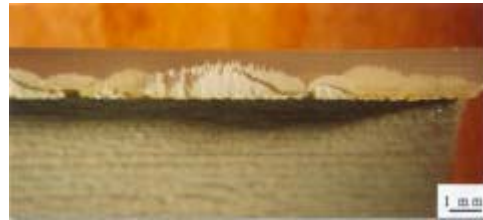
Figure 4: Axial Cross-section of PEX Pipe Material.

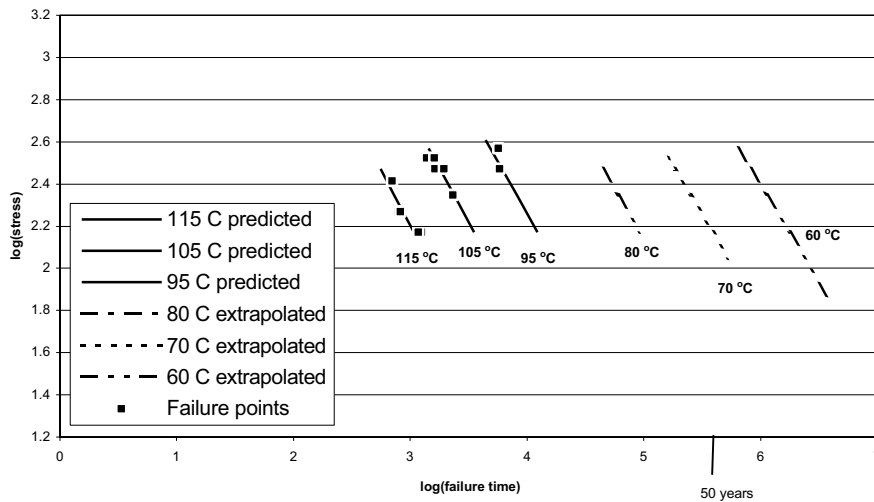
Figure 5: Failure Times for a PEX Pipe Material Exposed to Chlorinated Potable Water.

[Figure 5](#) shows a plot of the experimental failure points and the predicted failure times from the Rate Process Model. From the data it is seen that the Rate Process Model provides a good fit to the experimental data. The R² for the regression was 0.98. Also shown in [Figure 5](#) are the extrapolated test lifetimes at lower temperatures.

For domestic plumbing applications the commonly accepted most aggressive end use conditions are 80 psi internal pressure and 60 °C (140 °F) temperature. In actual application both pressure and temperature, or the combination thereof, would be expected to be below these values. Moreover, most domestic plumbing systems do not experience continuous hot water conditions. These conditions would appear, therefore, to be relatively conservative. The extrapolated test lifetime for the PEX material tested based on these conditions is 93 years with a 95% lower confidence limit of 52 years. This estimate is based on testing at aggressive water quality conditions as well as extrapolation to aggressive end use conditions. Even though the presence of the chlorine in the potable water reduces the anticipated performance lifetime of the PEX pipe material tested, the material still appears to have very good chlorine resistance.
